NAVAL RESEARCH LAB WASHINGTON DC

NRL-MR-4473

## ULTRASONIC INSPECTION OF A GRAPHITE/EPOXY STRUCTURAL MEMBER USING A THICKNESS-IMAGING DEVICE

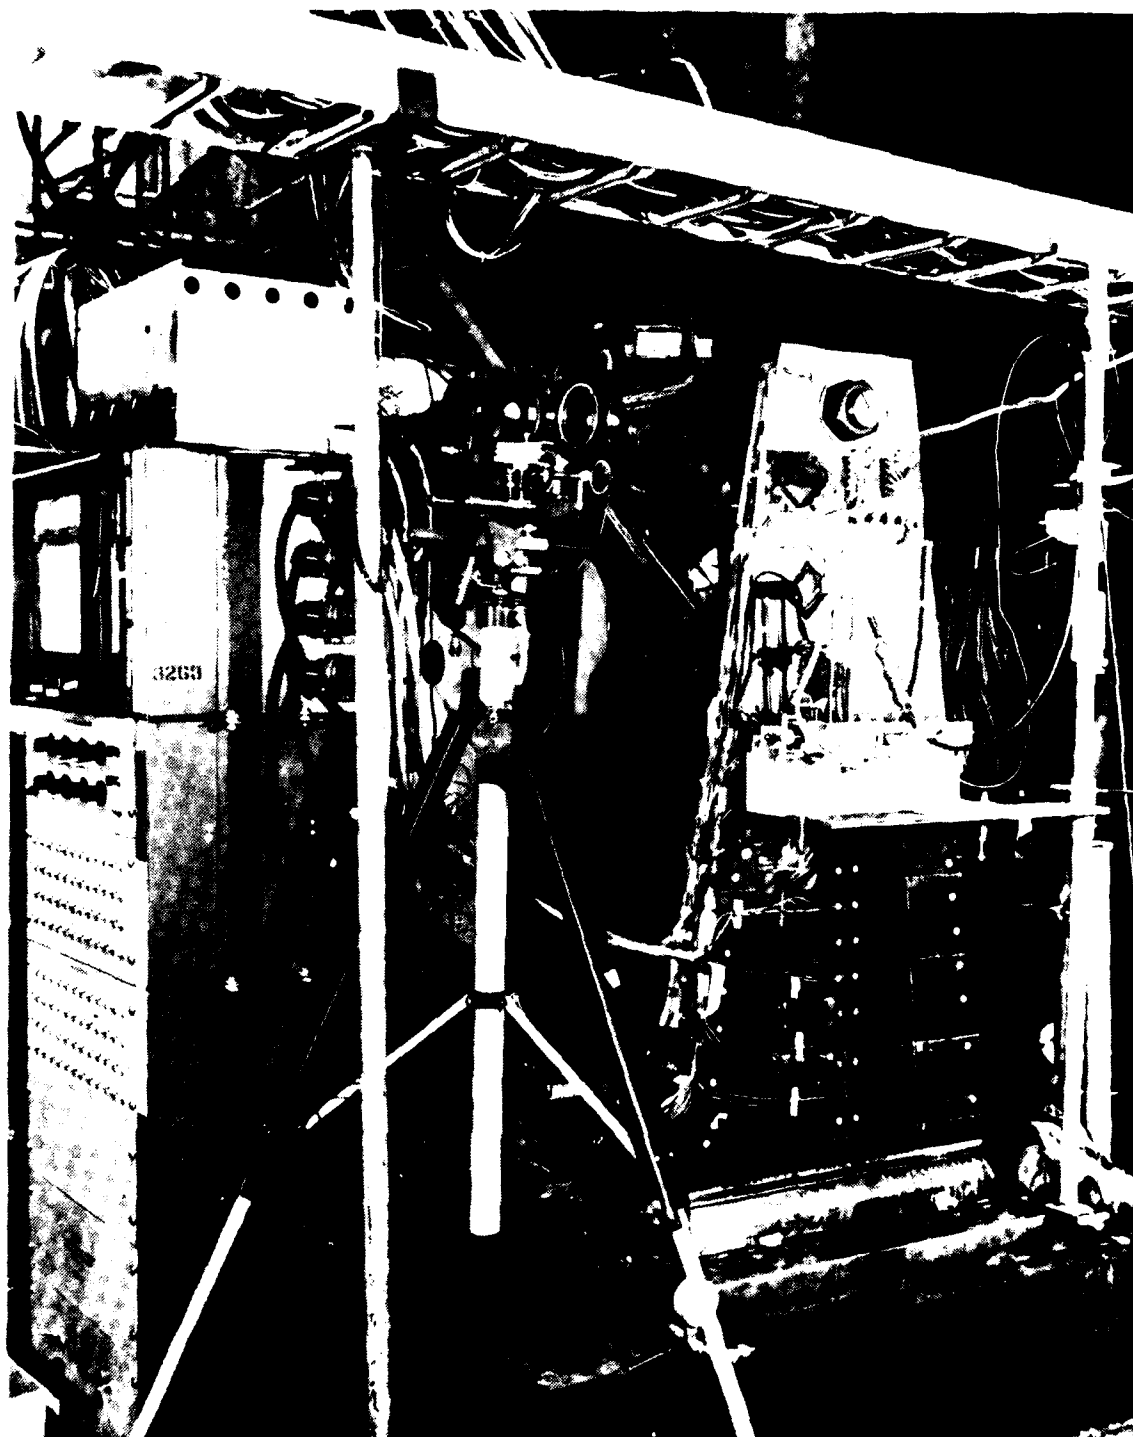
Fig. 4 — Box Beam in test frame

The Box Beam was set-up in the test frame as shown in Fig. 4. A hydraulic ram was attached to the top of the beam, providing the means of applying the required loads. Grid marks drawn and numbered on the graphite/epoxy faces served as site references. Nine areas were selected to be inspected by the SCIMI instrument; shown in Fig. 5. These areas were chosen as a result of the hand scan previously done. Each area had a known delamination. In addition a few problem areas, such as beveled bolt heads and thinning walls at the scarf joint, were included in the scanning sites.

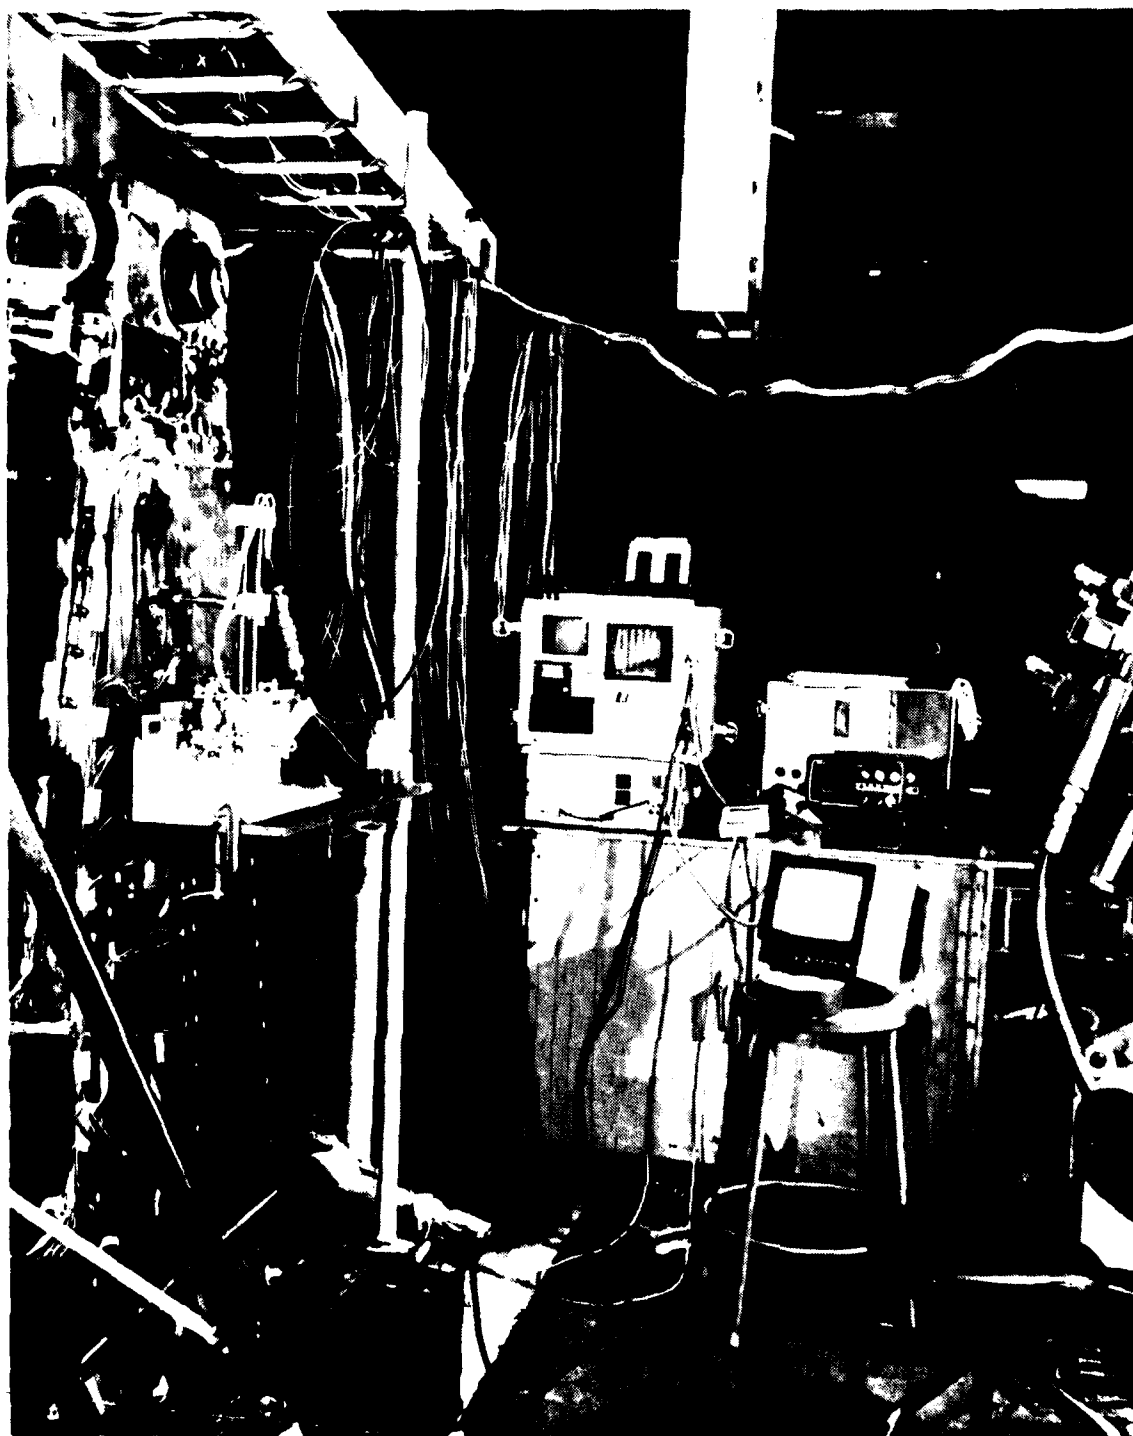
Fig 6 — The SCIMI instrument

The test set-up of the SCIMI system is shown in Fig. 6. A close-up of the scanner portion is shown in Fig. 7. A total of nine test areas on both the front and back faces of the Box Beam were inspected. The first series of scans provided baseline data. The next two series were taken after the beams were stressed to a low load. No major failures were expected and none were found in the areas selected to be monitored.
